Nuclear Cryogenic Propulsion Stage (NCPS) Fuel Element Testing in the Nuclear Thermal Rocket Element Environmental Simulator (NTREES)

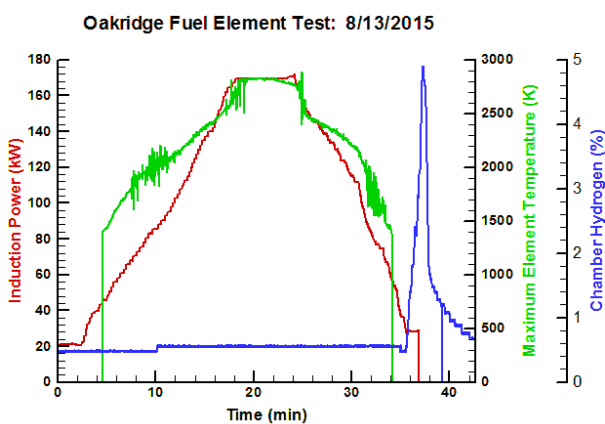
Figure 4 Aggressive Test Conditions

During this testing, the fuel element was above 2800 K for almost 4.5 minutes and was above 2500 K for over 8.5 minutes. The 2800 K temperature in the fuel element was achieved at an induction power level of approximately 169 kW or at just over 14% of the power available from the 1.2 MW induction heating unit. It was noticed near the end of the 4.5 minutes the fuel element was at 2800 K, that the temperature in the fuel element was starting rapidly fluctuate over a several hundred degree range and

generally decrease in magnitude. Simultaneously, the induction power in the induction heating unit started to increase slightly. This type of behavior indicated that fuel element damage was probably beginning to occur. The decision was then made to slowly decrease the induction power in the NTREES induction heater so as to slowly drop the temperature in the fuel element. After about 11 minutes, the induction power level had been reduced to approximately 30 kW and the temperature in the fuel element had been reduced to roughly 1000 K. At this point, the hydrogen concentration level in the chamber spiked significantly resulting in an automatic system shutdown wherein the induction power was cutoff and the main hydrogen inlet valves were closed. System purging with nitrogen was also initiated as a result of the shutdown. The cause of the hydrogen concentration spike was thought to almost certainly be due to the catastrophic failure of the fuel element. Such a failure would cause the hydrogen normally flowing through the fuel element to discharge directly into the NTREES chamber rather than into the hydrogen/nitrogen mixer assembly as would be the case if the fuel element were still intact. Upon removal of the fuel element from the chamber, it was indeed confirmed that the fuel element had failed catastrophically as shown in the post test photograph illustrated in Figure 6. It should be emphasized that the conditions under which the fuel element failed were well in excess of those at which fuel failure was expected to occur and demonstrated considerable robustness in a very preliminary fuel element configuration.
